Difficult Fixing. Perhaps it would be better to say “Difficulty”

This month’s difficulty can result in an MoT failure. On several occasions my E9 has failed its MoT first time around because the indicators work, but the indicator “indicating light” at the bottom of the speedometer, which should flash when the indicators are working, doesn’t. My usual solution is to charge up the battery overnight and return for a retest the next day. The indicators usually work for a few days after that before returning to “no indication”.

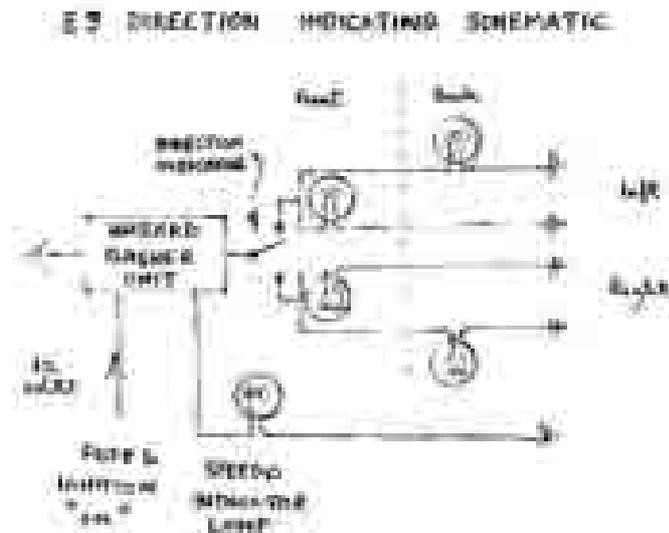
For you (fellow) electricians out there, the simplified circuit is as shown.

Doing the maths, I calculated that a 6.8 ohm resistor wired in parallel with each of the rear lamps would increase the operating current through the flasher by about $\frac{1}{3}$ which would solve the problem.

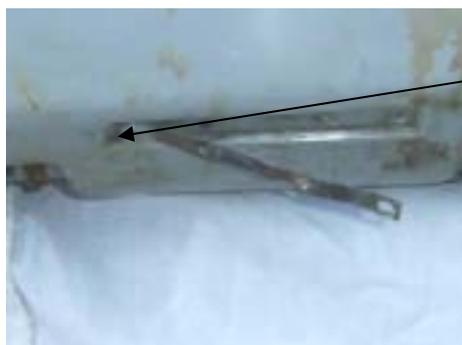
The rear light cluster has a metal earthing strip inset into its outer cover. When checking out my own car I found that this strip was one of the sources of the increased resistance because the alloy rivets connecting the brass strip to the lamp fittings inside the cluster had corroded (white grunge) and needed to be replaced. However the strip provided the ideal solution for attaching the extra resistor.

Corroded rivet. The other has been drilled out for replacement.

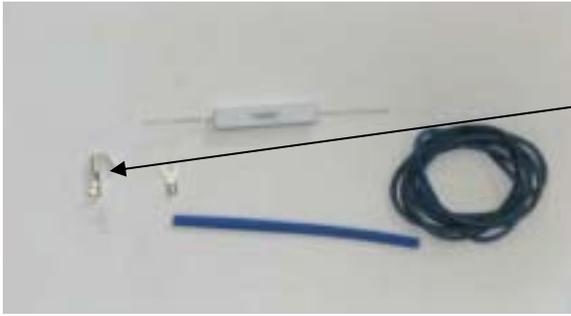
The circuit components.

Doubler

The completed circuit.

I ordered some resistors from Maplin on line (part number H6R8 - 6.8 ohms, 10 watt wire wound) and used a "doubler", a terminal eye and some wire to make up a resistor circuit.

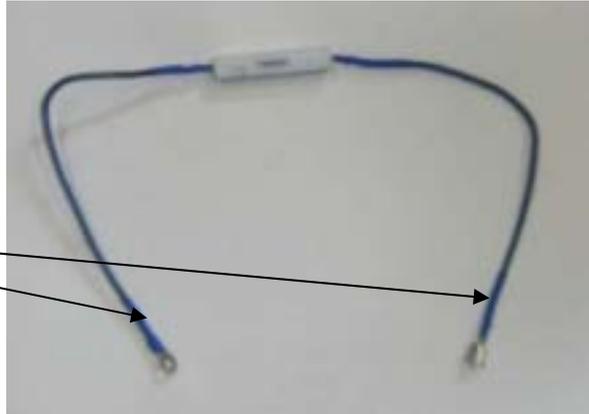
Thermofit sleeves

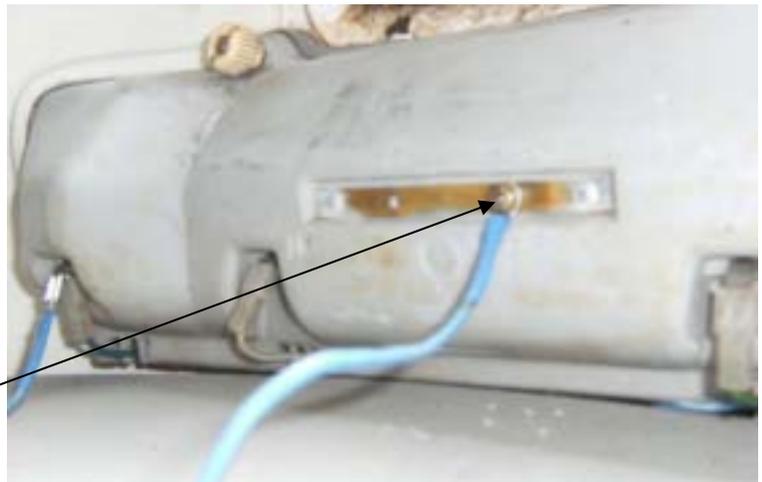
Self tapping screw to earthing strip

I then drilled a 3 mm hole into the rear light cluster plastic housing through a very useful hole already punched in the brass strip, and attached the terminal eye to the strip with a self tapping screw.

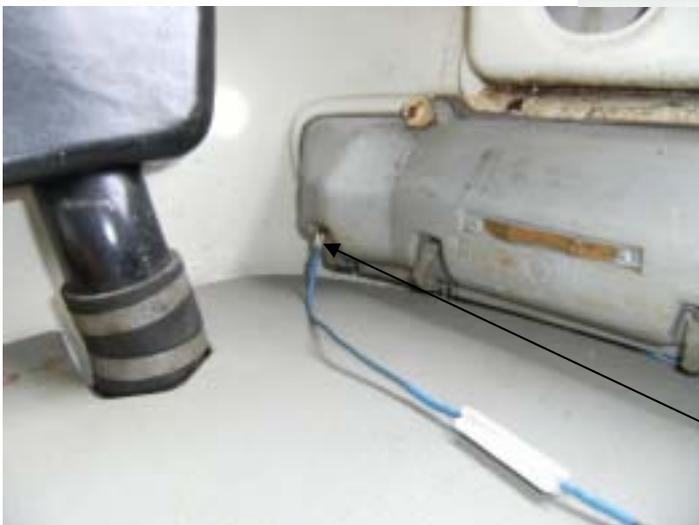
Doubler connection for the wiring loom and the resistor circuit.

I then used the doubler to attach the resistor to the connection for loom cable which feeds the indicator.
