[Mechanical Tii Distributor '72 ; PN: 0231151008 "JFUD4"](#)

Rebuilding the Bosch 010 Distributor – Part II

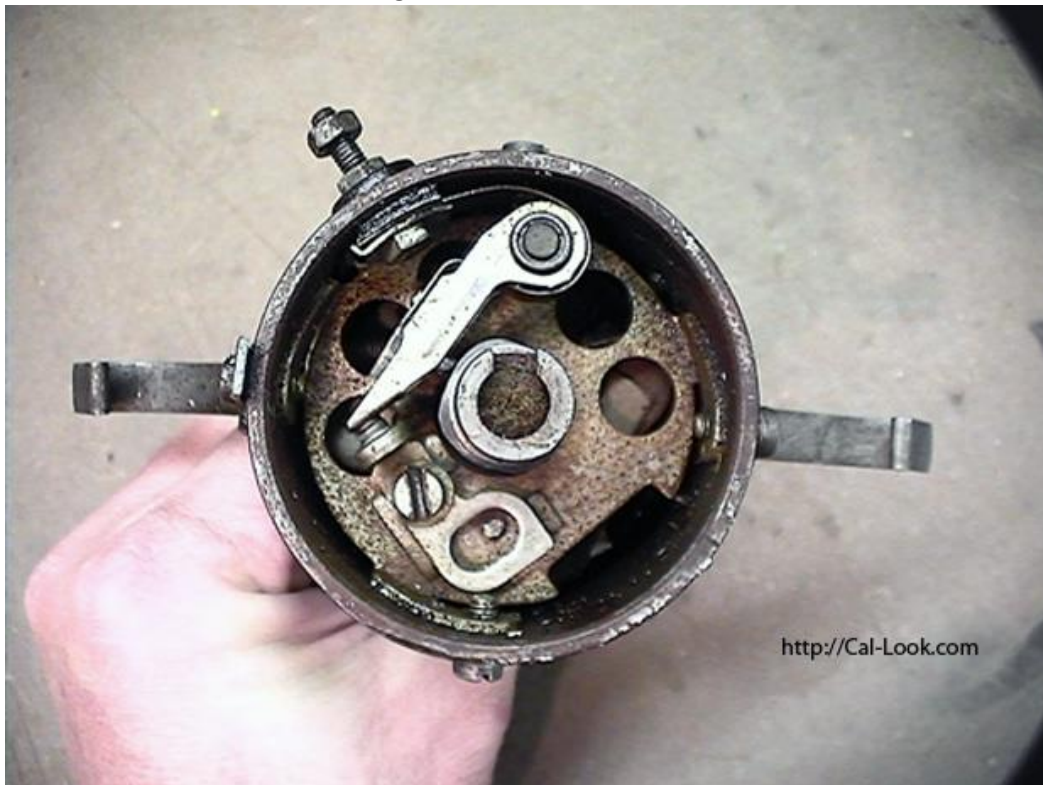
↑ This is the inside – some rust but everything's there.

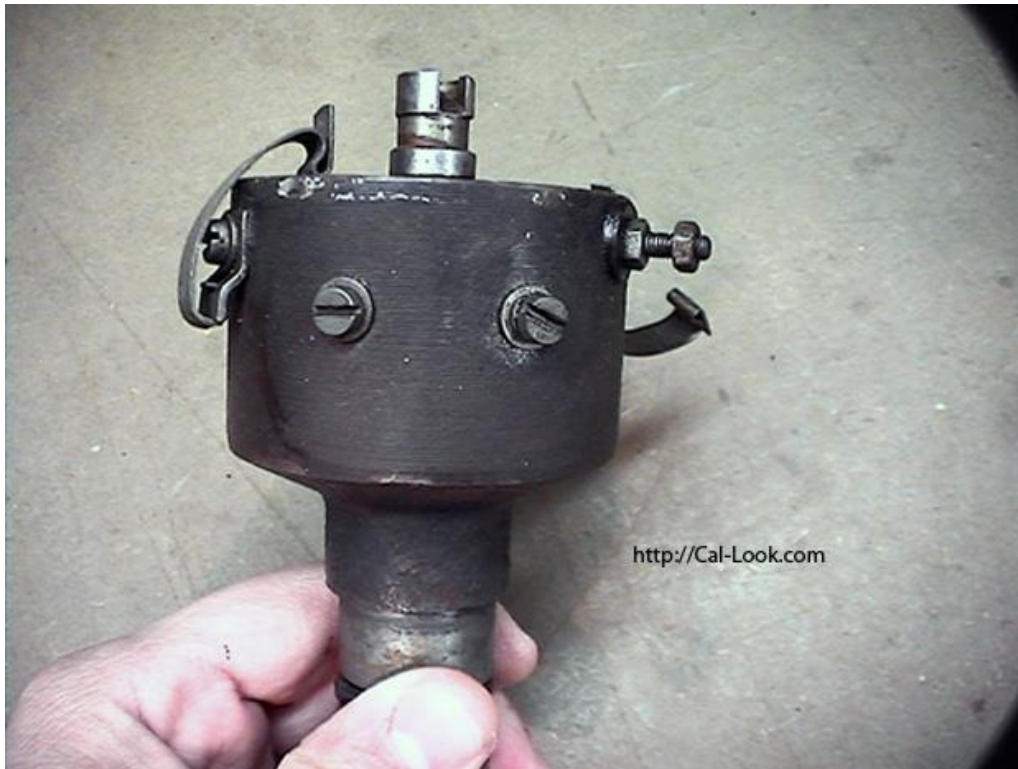
↑ Here's the back – no condenser or bracket.

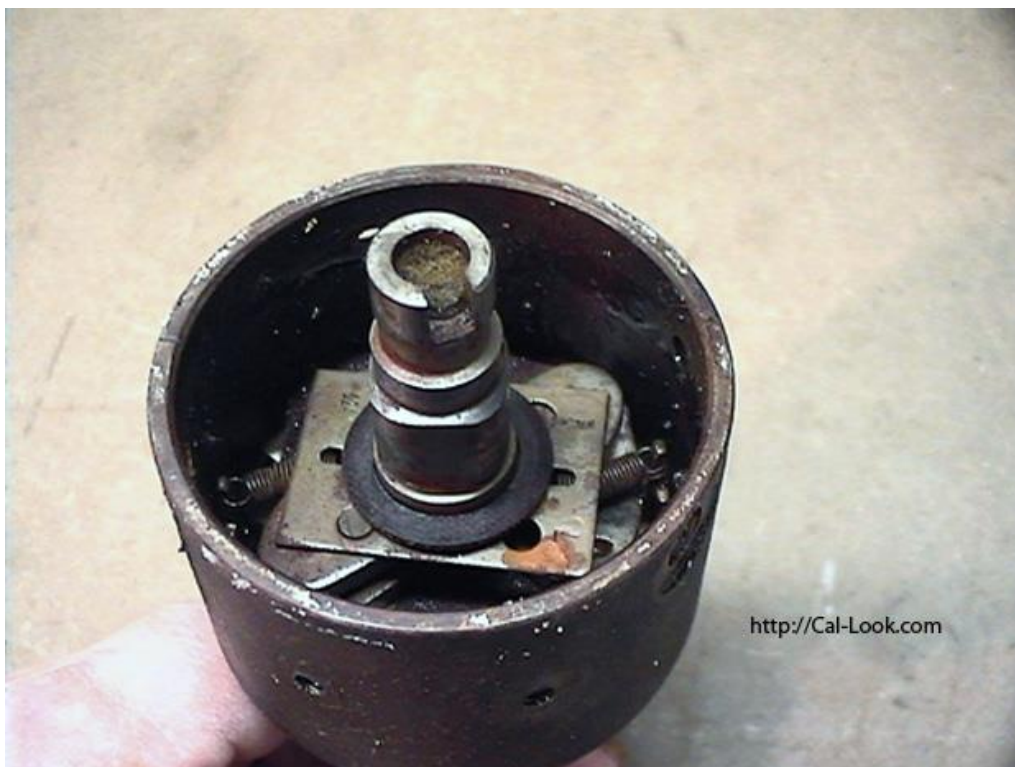
↑ Notice the “fiber” washer – they’re very fragile.

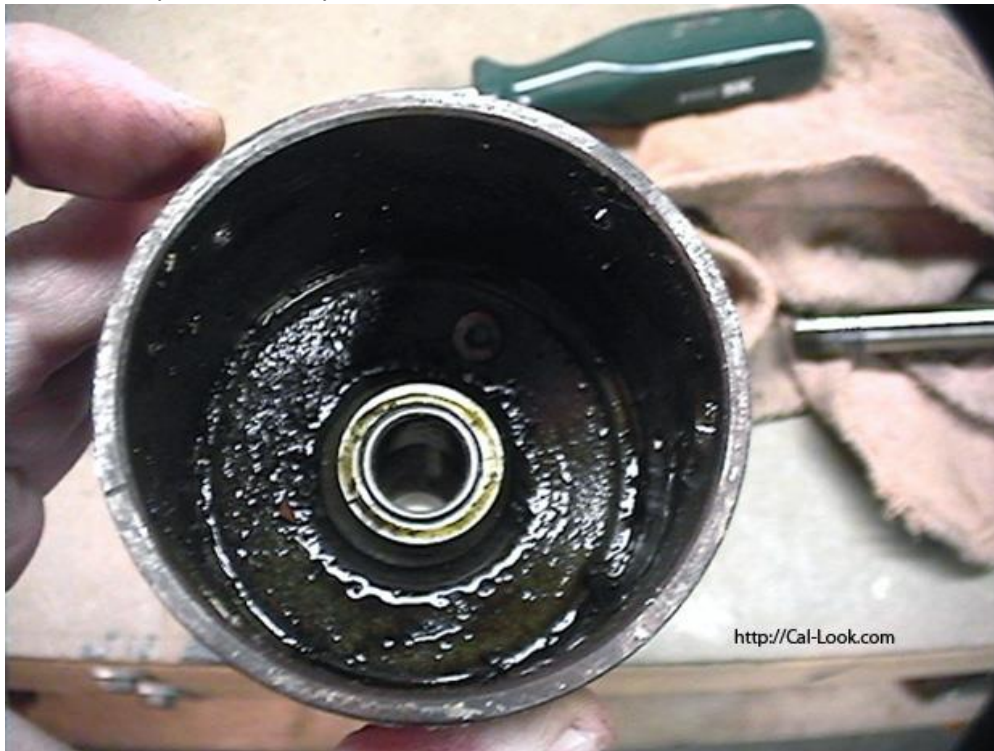
↑ Pretty greasy – that's 40 years of oil and dirt.

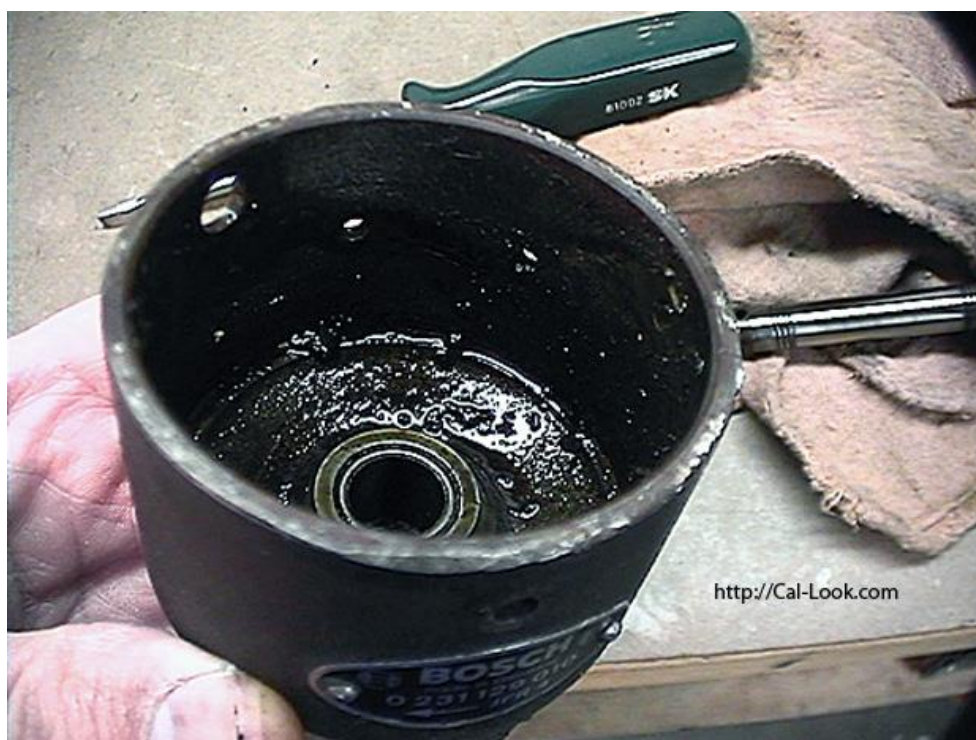
↑ Now you know why I rebuild these.

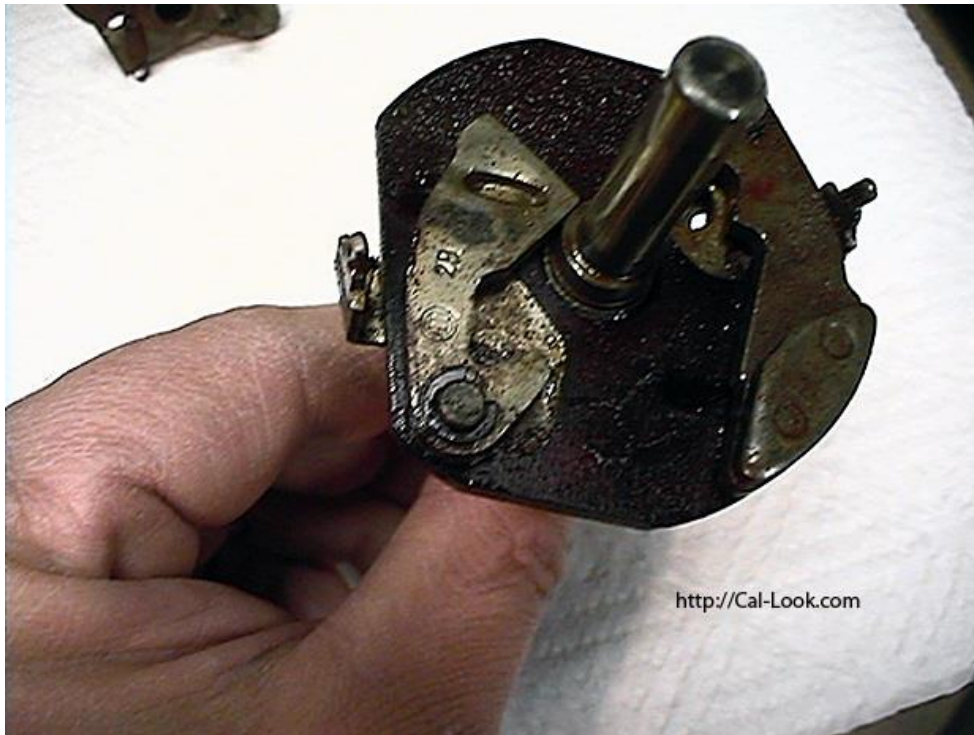
↑ Under the weights are small washer/spacers. Finally there is a very thin and fragile plate that needs to be removed. If you are not very careful, it WILL crack.

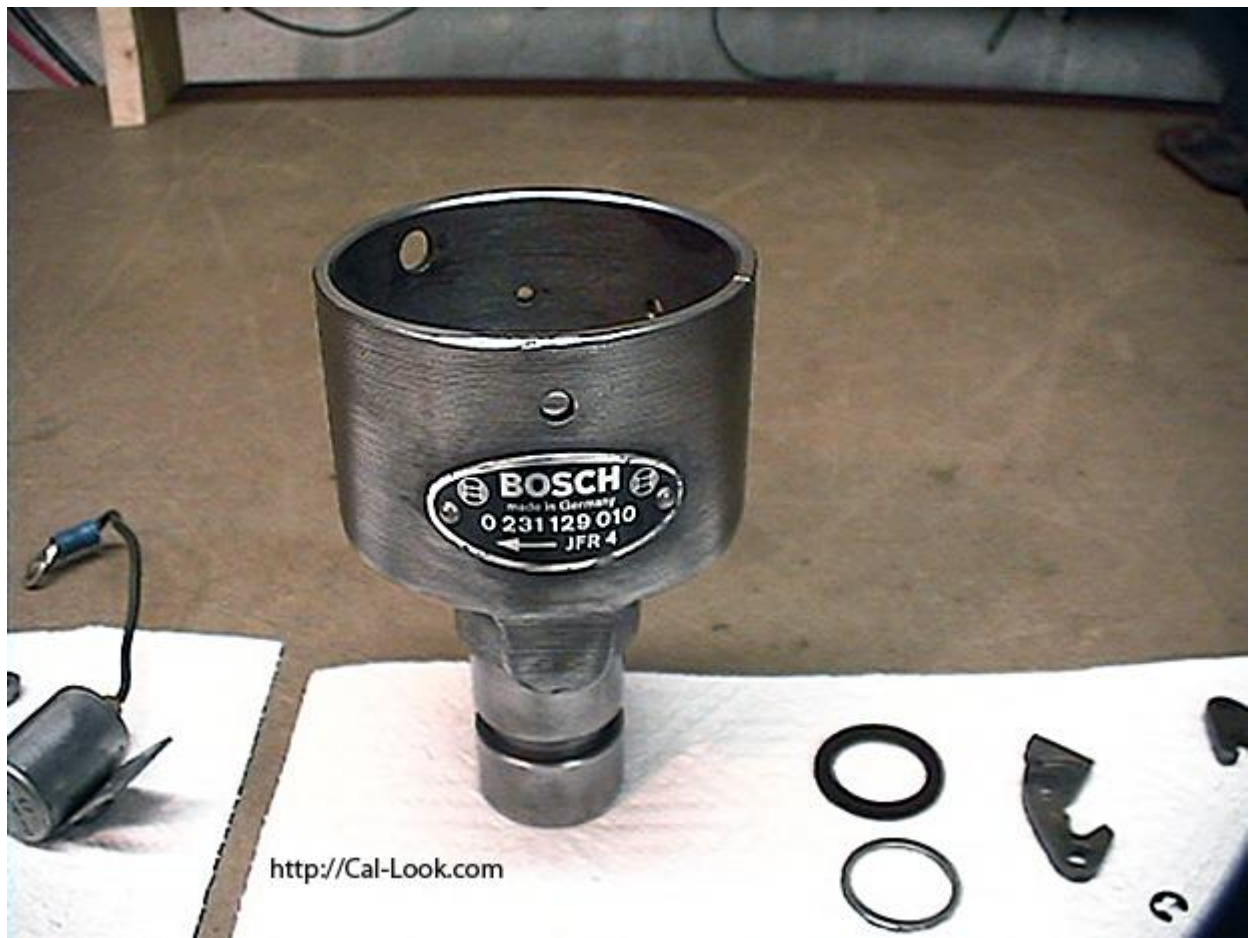
↑ The body has been totally stripped and is ready for paint.
