Mandatory Pre-PPI photos-BMW E9

The ten most common rust areas on a BMW E9

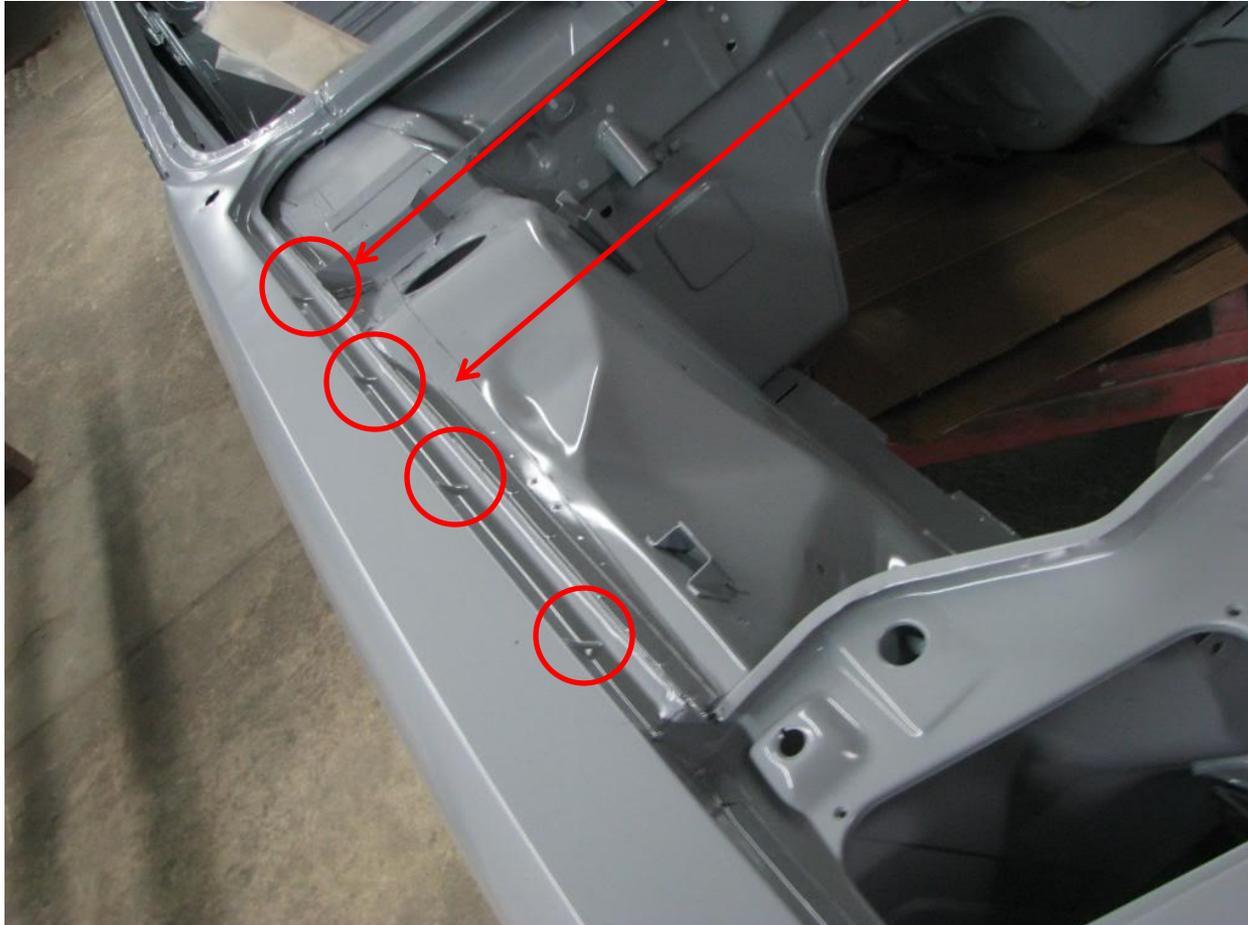
Photo No. 1 -The top of the front fender

This is the seam where the Karmann assembler welded the E9 fender to an intermediate panel at the top of the inner fender. Each fender will have 4 tooling dimples as shown below. If they are not intact this is strong indicator of prior rust work or poor repair. There is a 'shelf' underneath this seam (above the tire) that collects dirt, rust will form here and destroy this seam from the bottom up.

E9 front fenders are exceedingly difficult to fit to the uni-body, so sub-par repairs are common

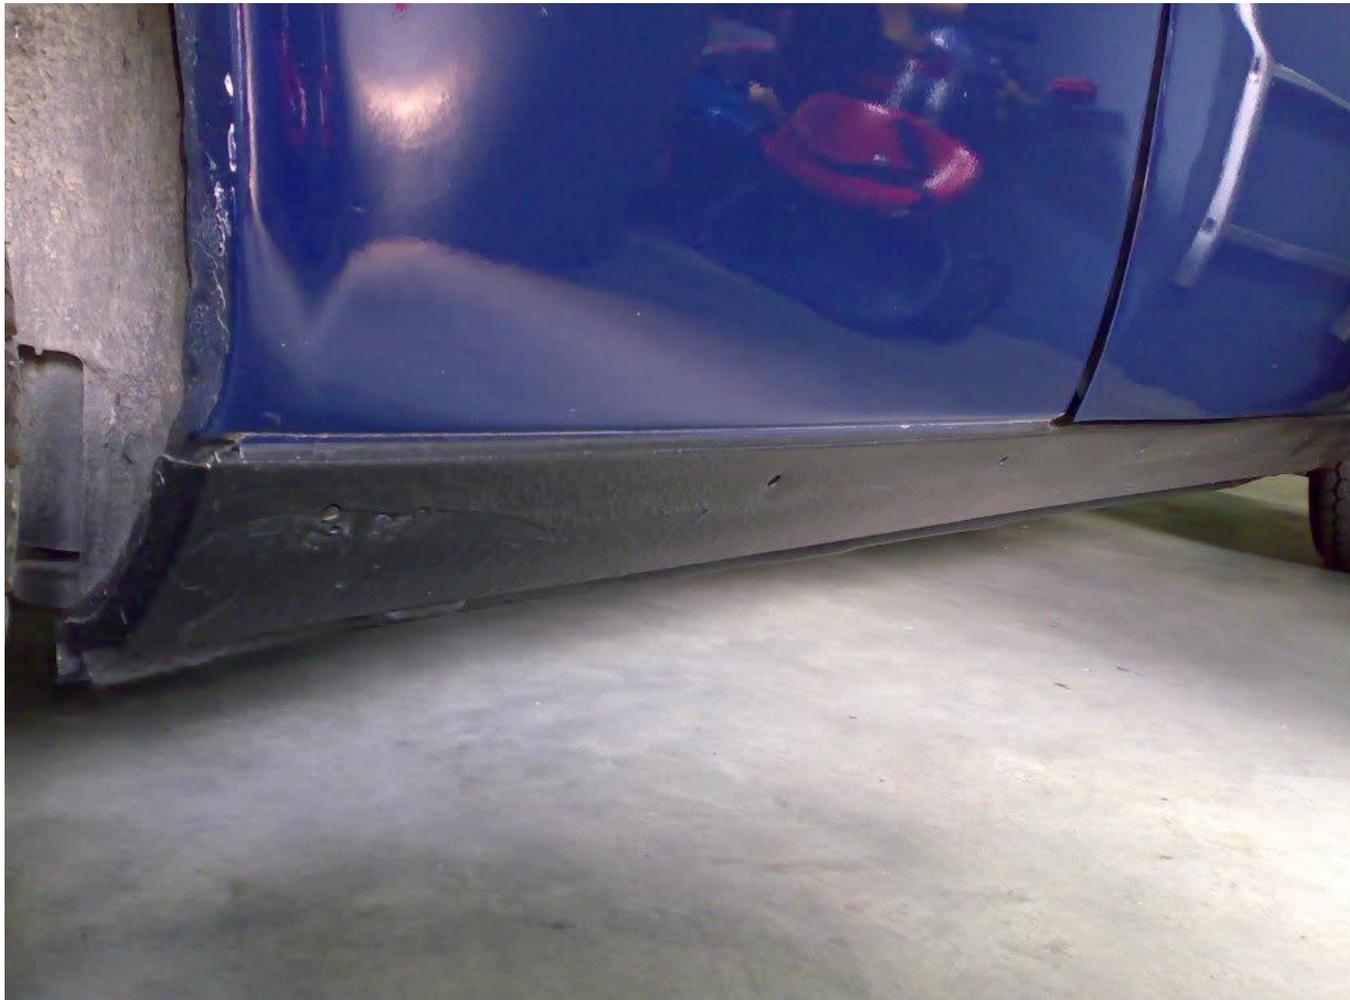
Decorative Trim panel (black) is non structural and hides inner sill rust

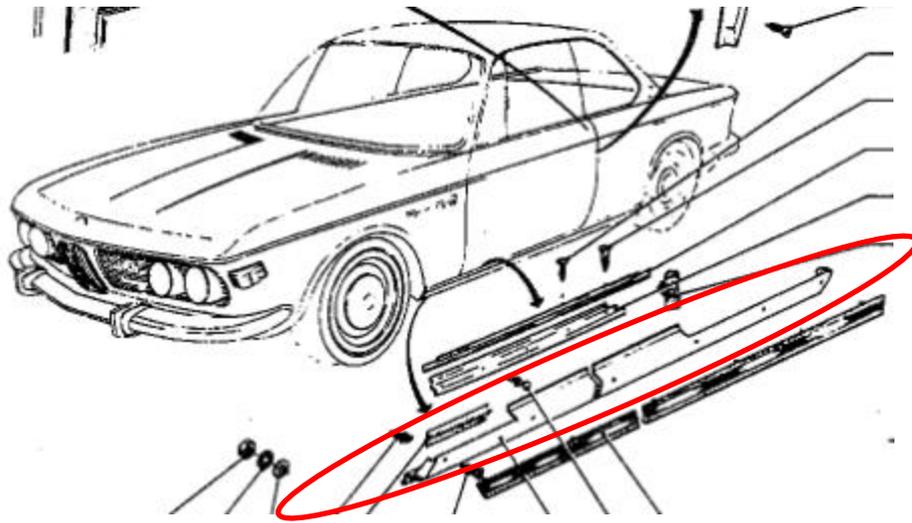
Photo No. 2 the lower sills

All Coupes have an outer decorative trim panel that cover the structural sill underneath. These outer covers are 'trim' and frequently don't rust. They cover the lower sill from fender well to fender well and mask the true condition underneath

It is imperative you remove these trim panels and inspect to condition of the real sills underneath

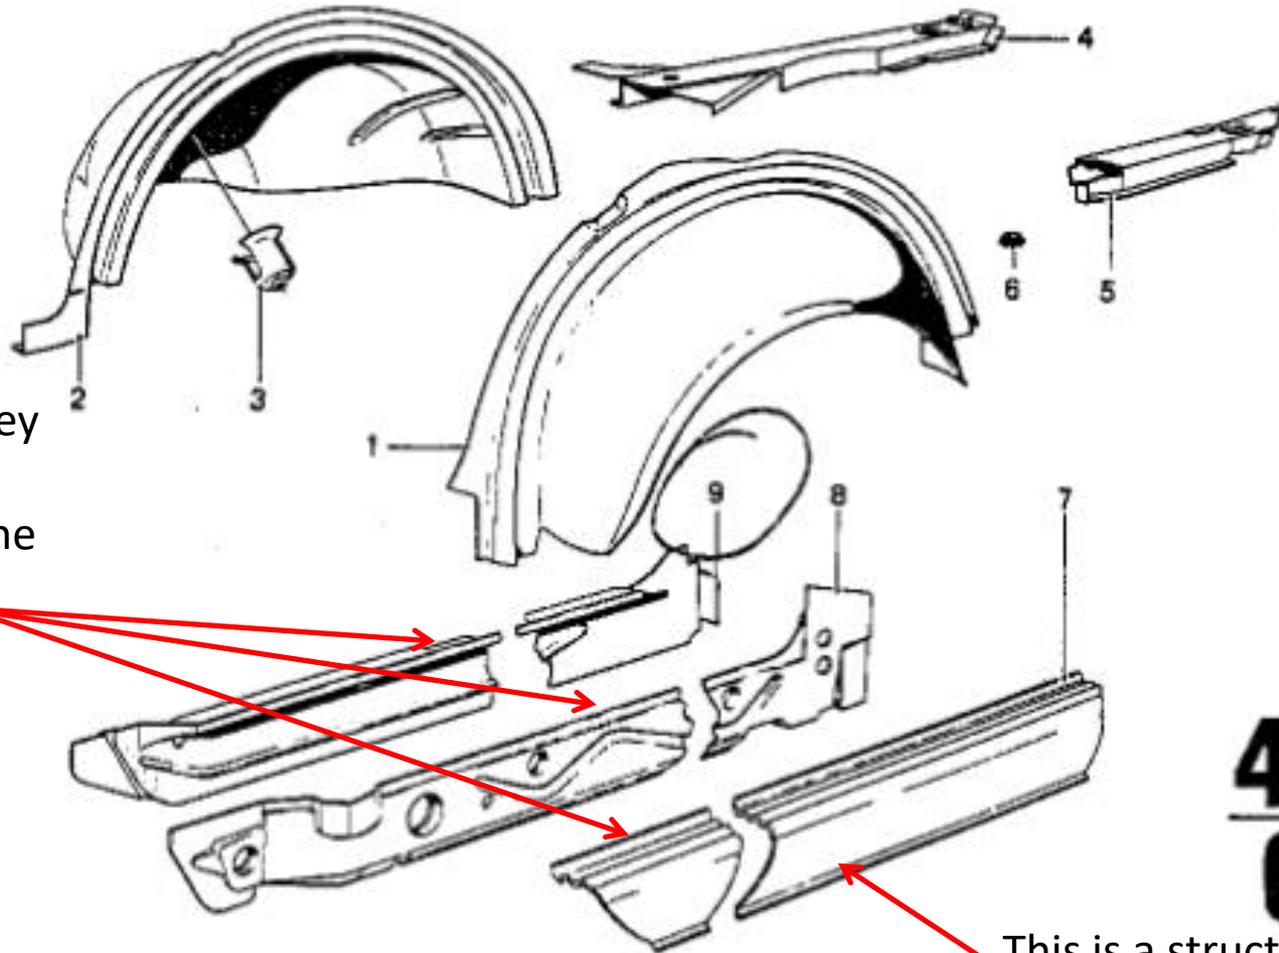
Serious Structural Rust Area –E9

These three sills are the key structural member of the E9 unibody.

This is a structural member, Not the decorative out sill
