Rescue and Rehab of 2002 Cars and Parts

Replacing the Fuel Sender Tube Sleeve

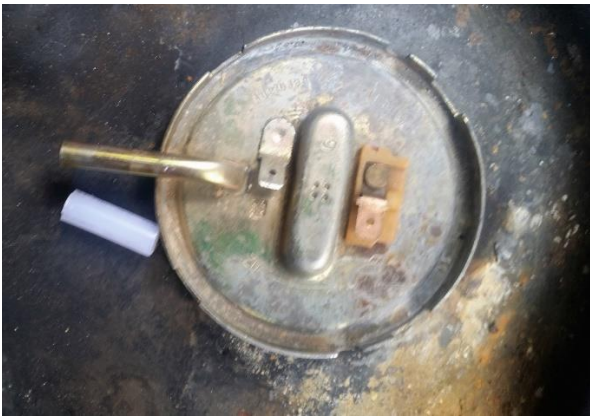
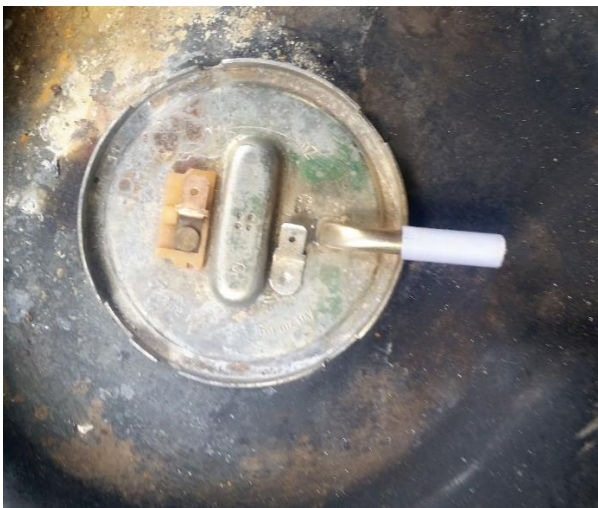
It is simple to replace. Remove the fuel hose from the sender tube, remove the old sleeve if it is still there, and slid the new one onto the filler tube. Re-install the fuel hose and voila! One more source of gas smell eliminated.

Over time the fuel sender tube sleeve deteriorates allowing gas to leak into the car. Or, more often than not, it was not replaced when new fuel hose was installed because a new one wasn't available. Well, here is a free one to solve this problem!
