2002s —ONLY—

Replacing the Fuel Sender Tube Sleeve

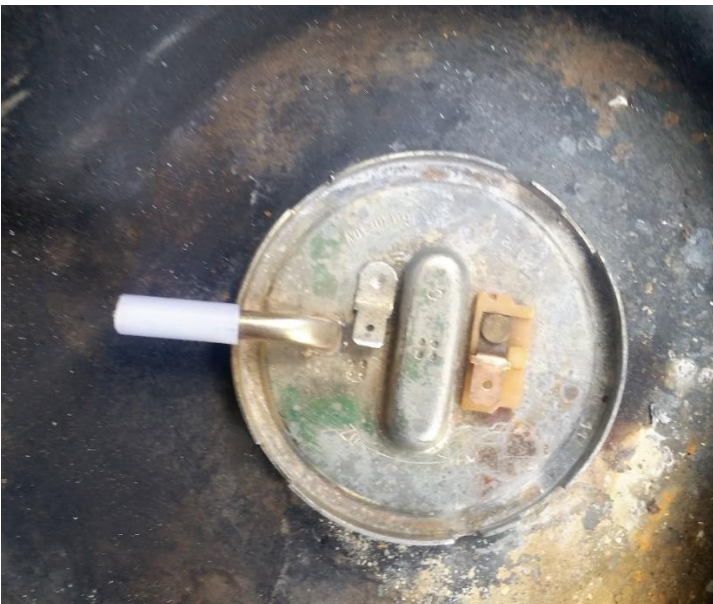
Over time the fuel sender tube sleeve on the 2002s deteriorates allowing gas to leak into the car. Or, more often than not, it was not replaced when new fuel hose was installed because a new one wasn't available.

It is simple to replace. Remove the fuel hose from the sender tube, remove the old sleeve if it is still there, and slid the new one onto the filler tube (you might need to lube the tube with some oil as it is a tight fit). Re-install the fuel hose and voila! One more source of gas smell eliminated.
