# Replacing the Speedometer and Clock in a 3.0CS

Photos and text by Michael Thompson

This procedure was done on a 1972 3.0CS USA model with A/C and electric windows. Yours will be a little different even if it is the same model and year as mine...

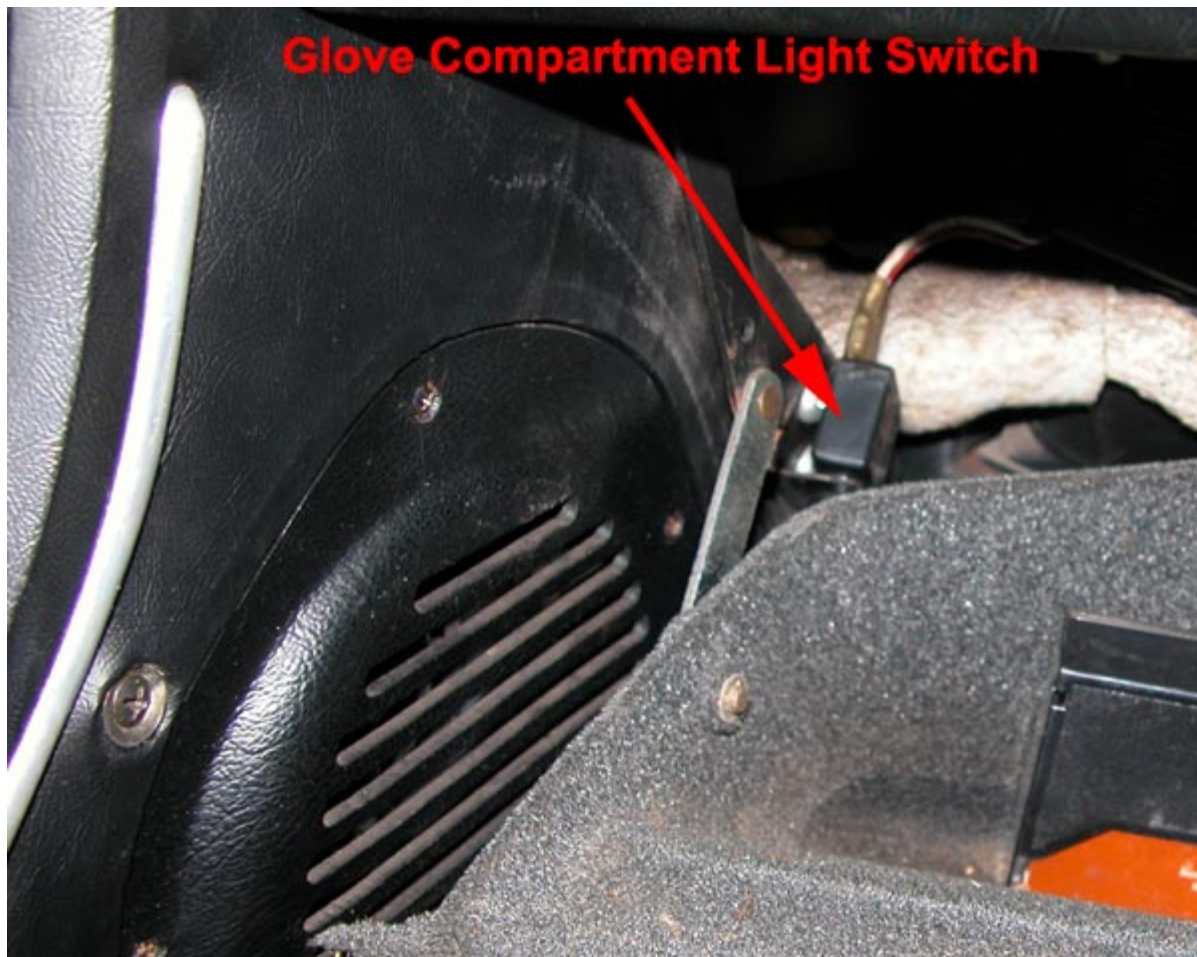
You need to remove the glove compartment light switch. I pulled both wires so the light would not stay on. There is a plastic nut that holds the switch to a bracket on the right console side.

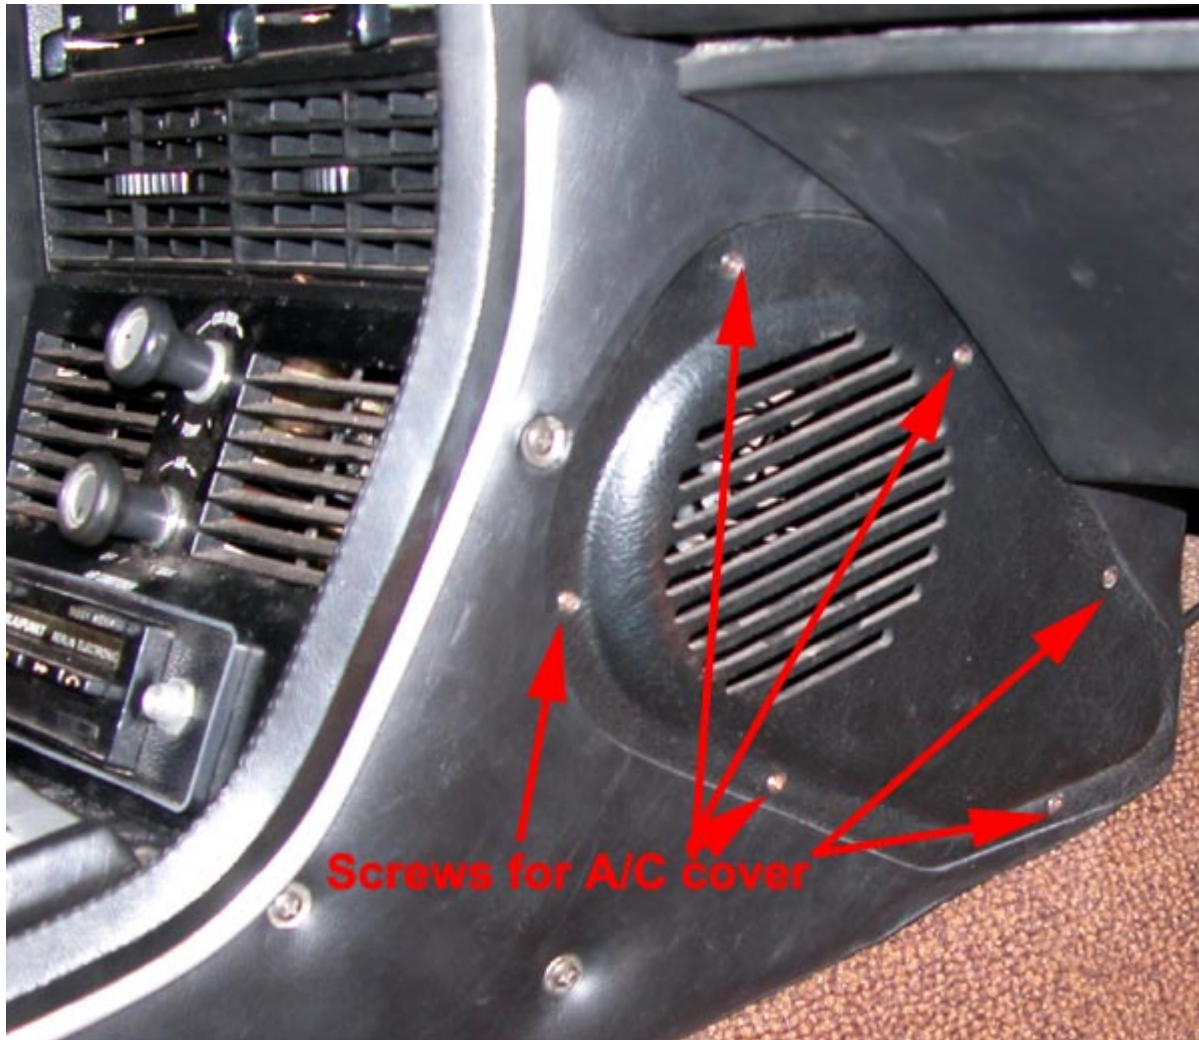
Console removal starts with removing the A/C air inlet covers (if you have A/C). Six little screws hold the cover on. The procedure is the same for both sides.

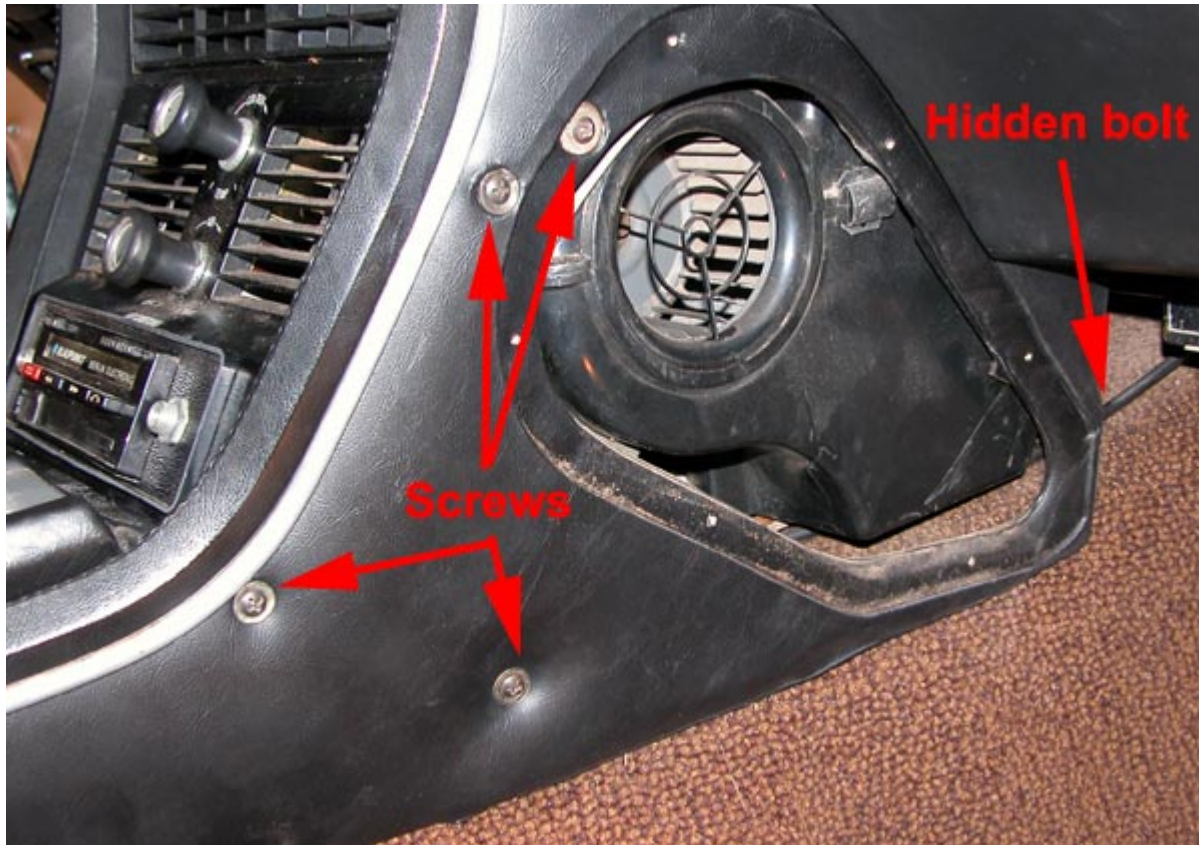
Then you need to remove four screws and one well hidden bolt. There is a nut on the bolt that is not attached to anything. Be careful or you will drop it and have a difficult time finding it.

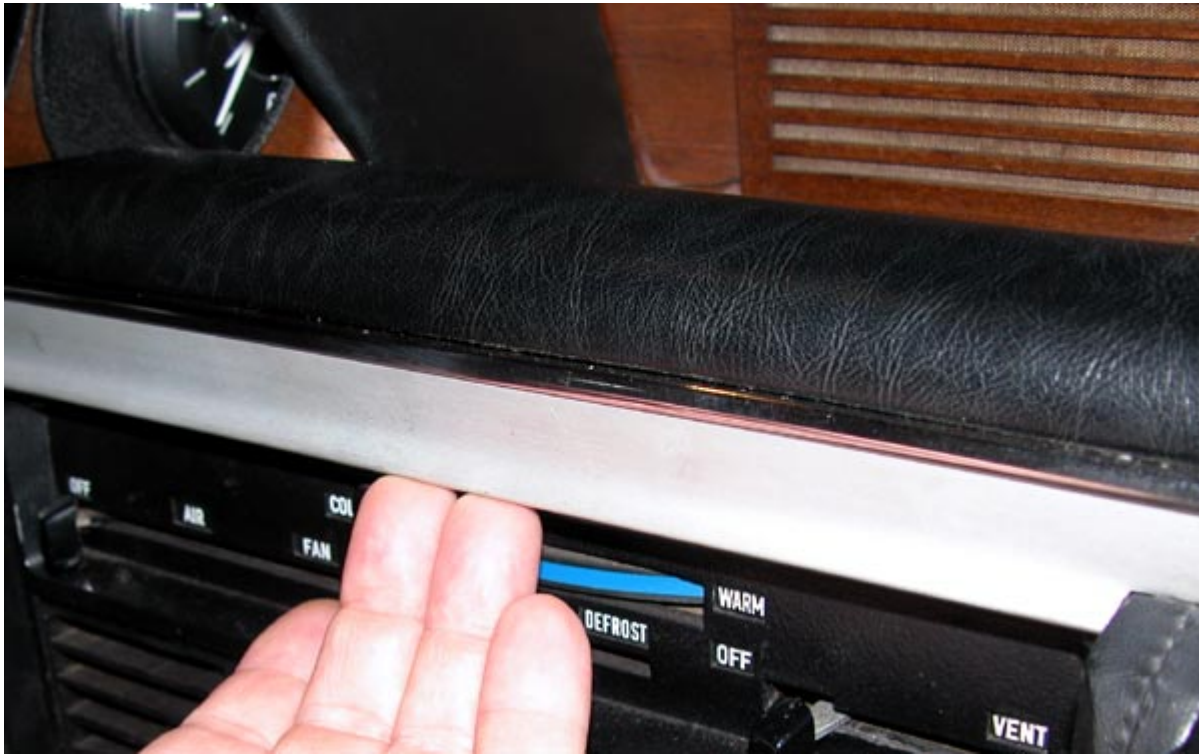
I removed the lip at the back of the dash shelf for more access. If you put your fingers under the trim and carefully pull, it will come off the dash. It is only held on by little push in studs. The stainless steel at the top of this trim comes off easily. Now is the time to polish it.

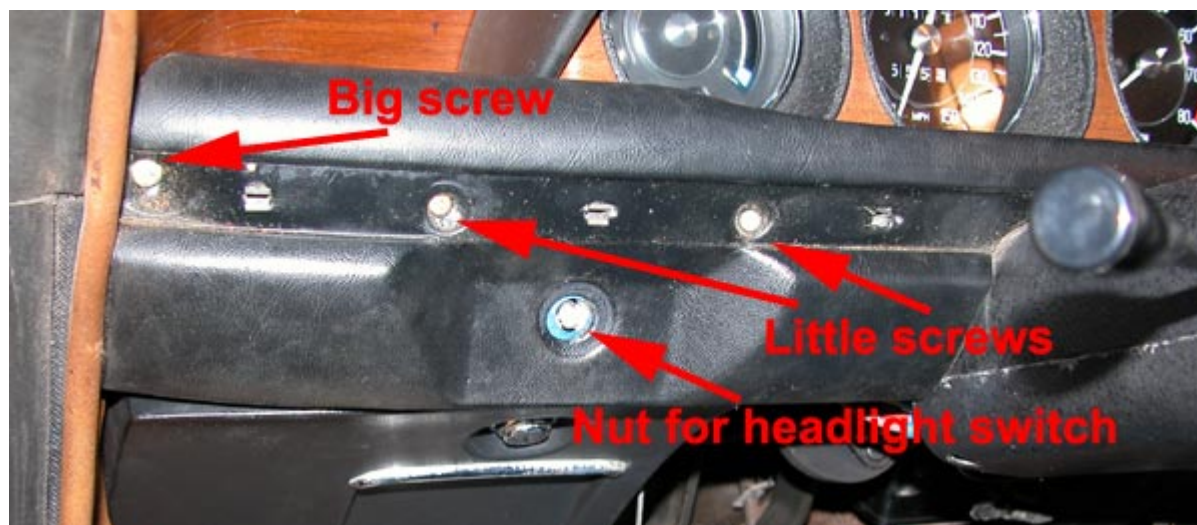
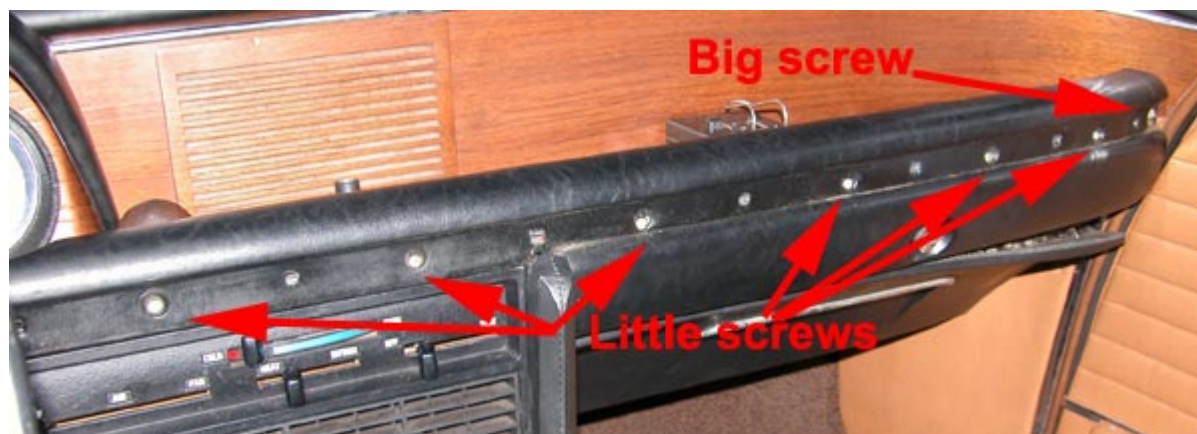
Once the trim is off you can see the big screws at each end, and the little screws that hold the lip onto the dash. With this part off it was much easier to get the sides of the console off.

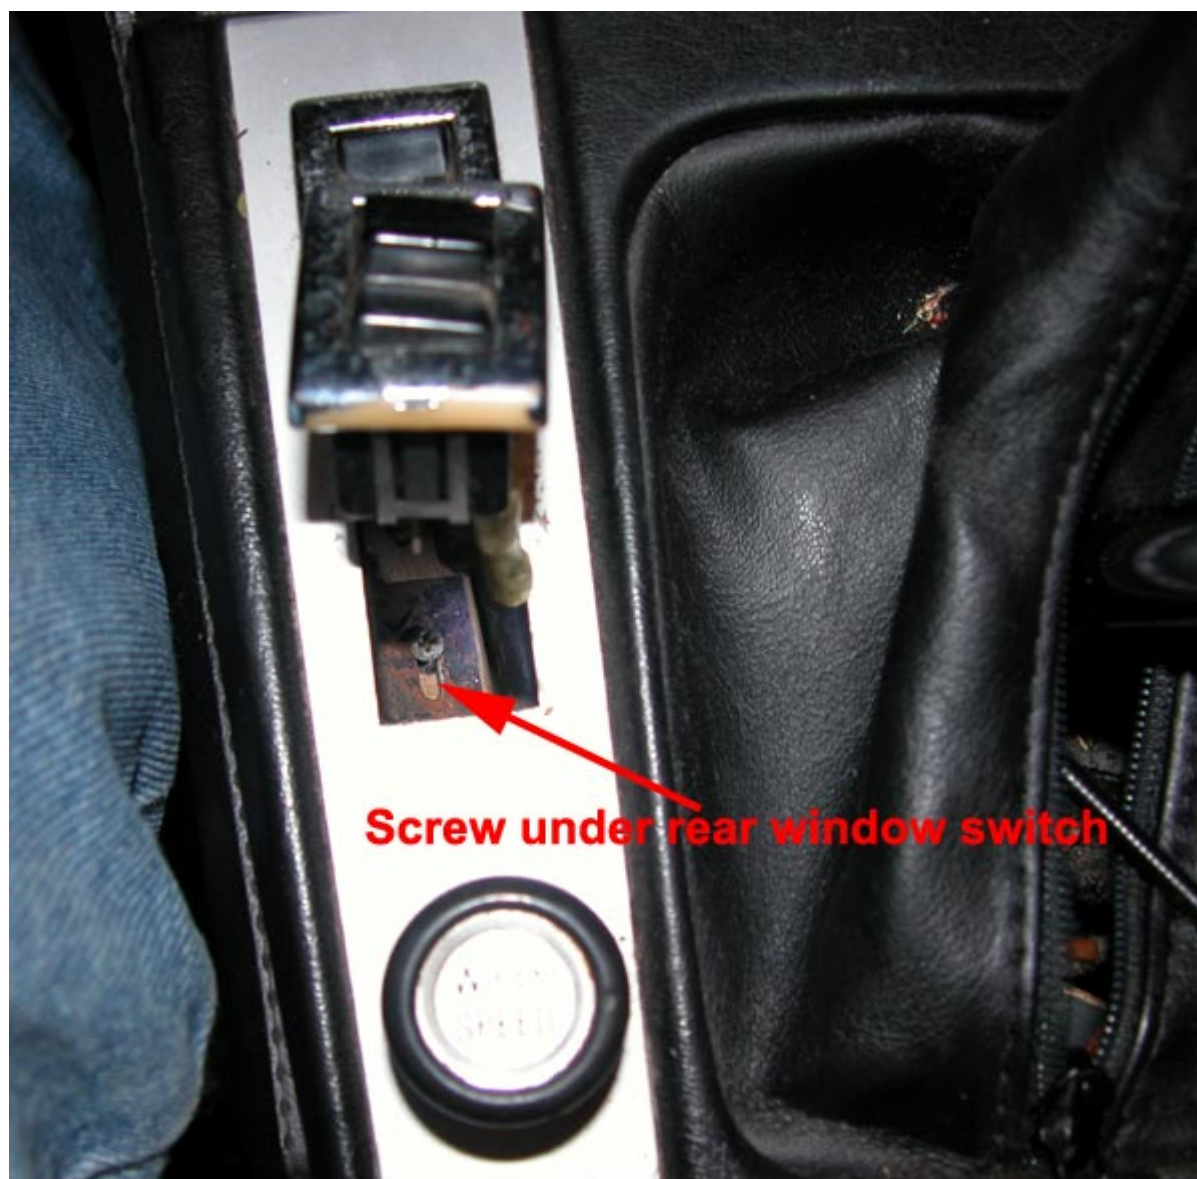
There is a screw under each rear window switch. Carefully lift out the switch. I found it easier to unzip the shifter boot and push the switches up from below. With the switch out of the way you can see the screws.

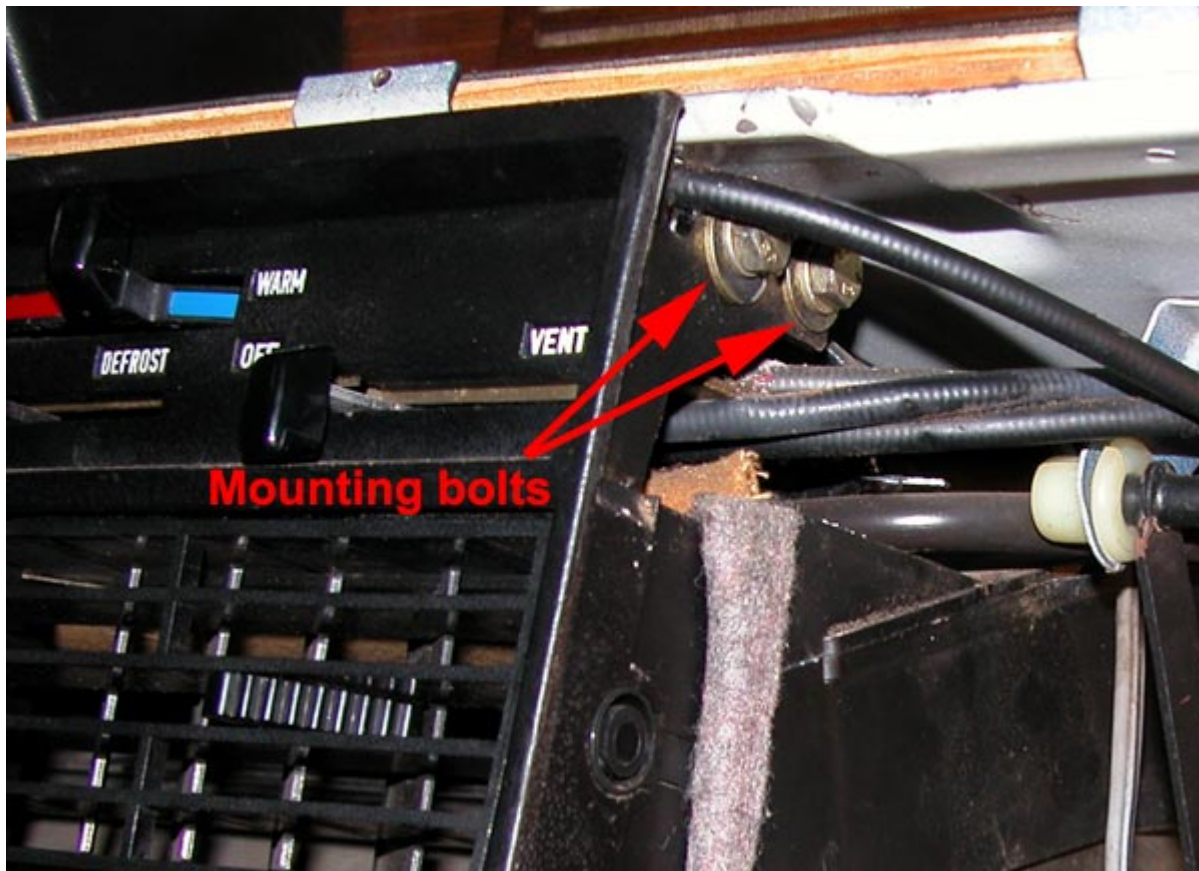
I removed the heater controls for more access, just like it says in the manual. There are two bolts on each side. The front right bolt on mine was missing. I dug through the hardware that I found in the car when I fixed the floor and there it was. The threads in the captive nut were damaged so Fritz threw it on the floor.

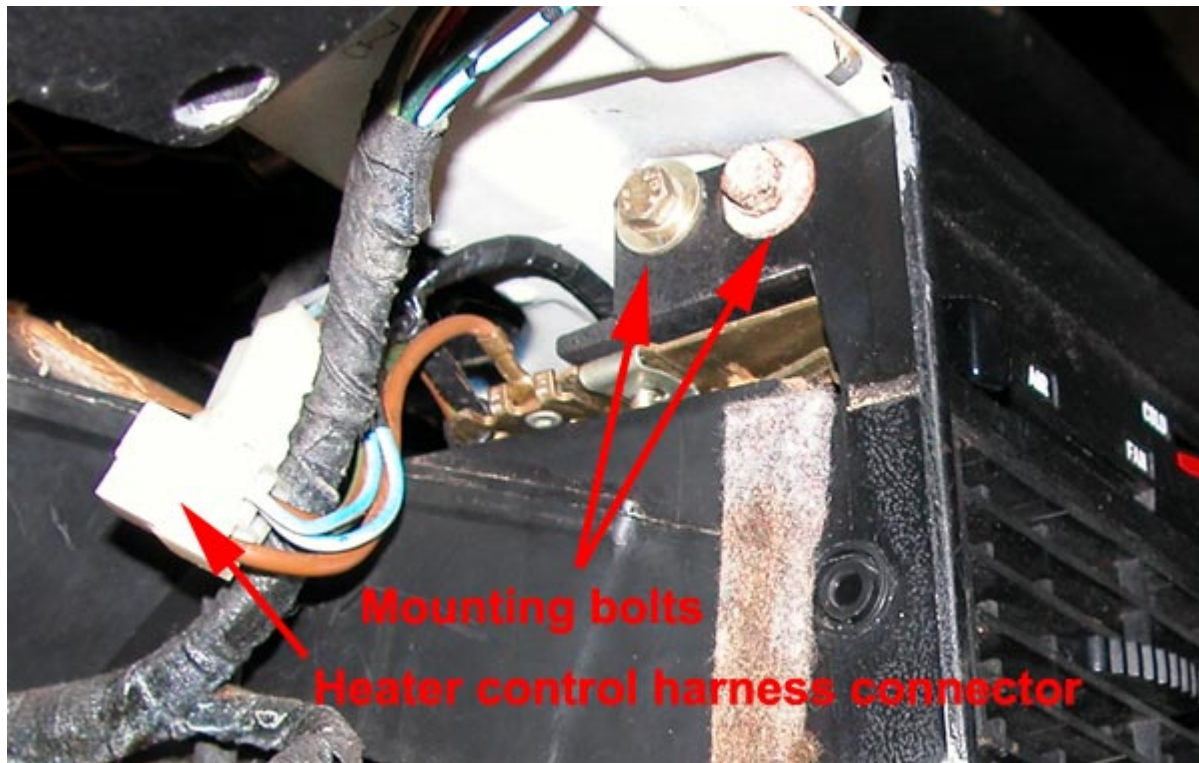
There is a wire harness at the left that needs to be disconnected. I didn't completely remove the controls because I didn't want to readjust all of the control cables.

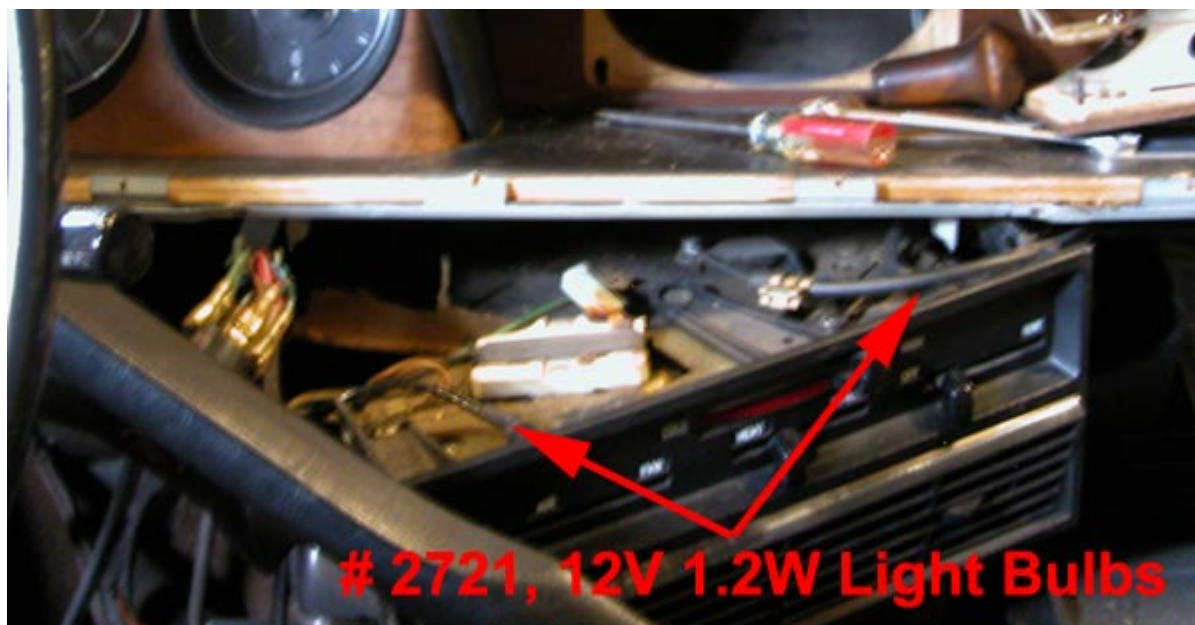
I was a little surprised to see that there were bulbs for the heater controls. Collective wisdom from a discussion on the E9 forum is that '73 and newer coupes have illuminated heater controls. My '72 has lots of '73 parts so that fits. The bulbs were #2712, 12V 1.2W. The local parts store had them for \$3.80 per pair. They also fit Mercedes, Audi, Volvo, Porsche, etc. so they should be easy to get.

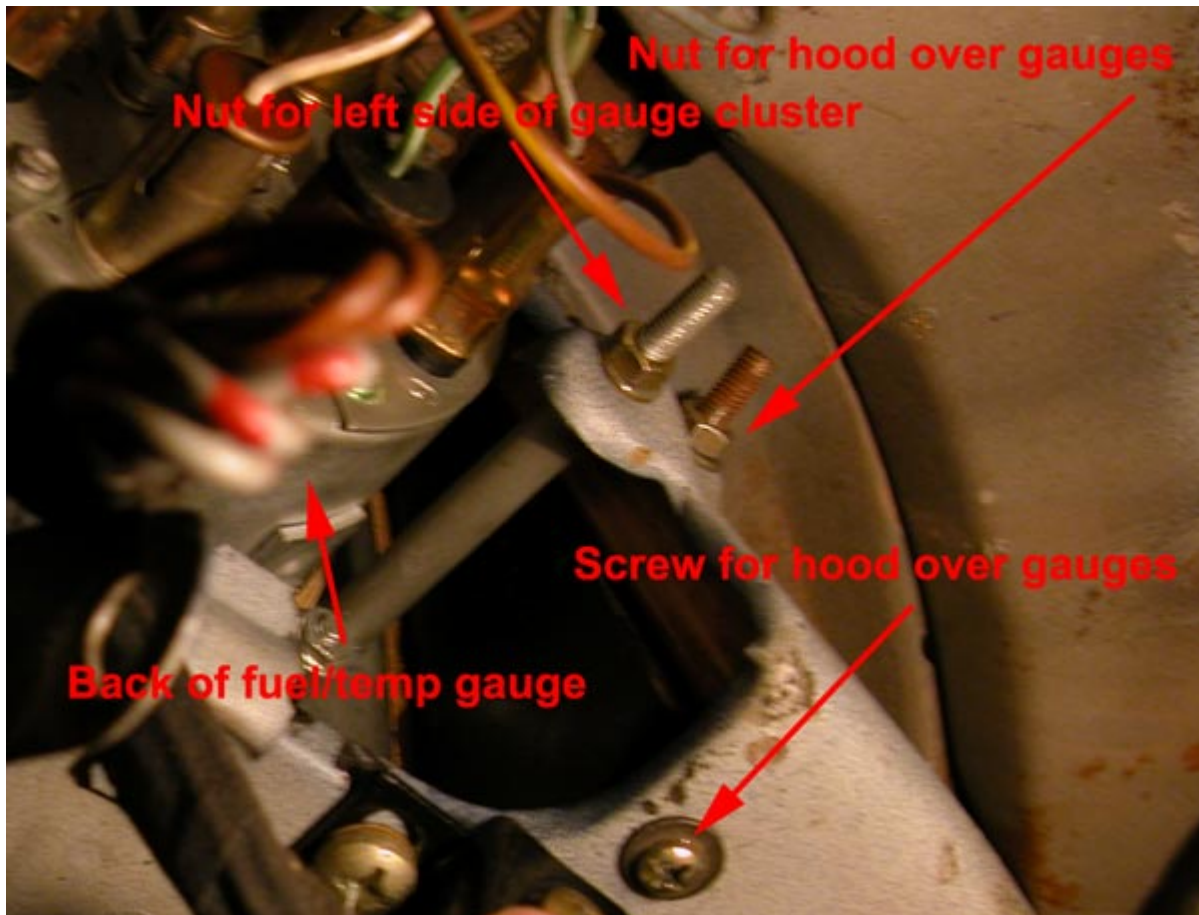
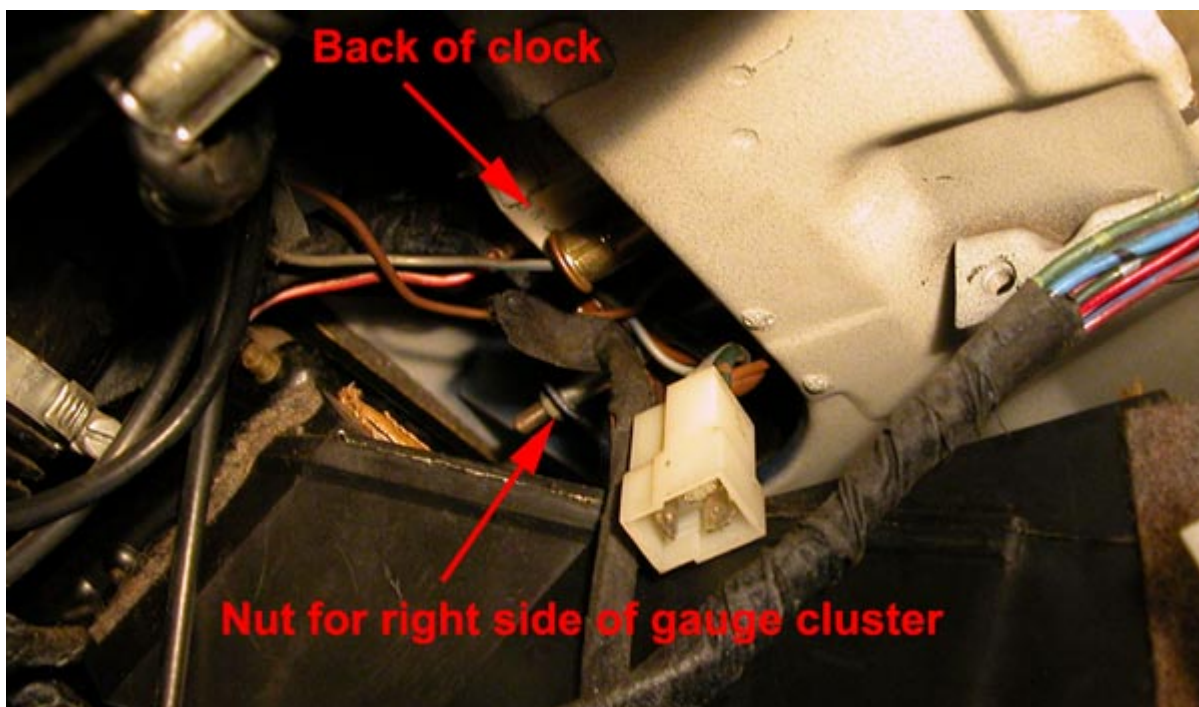
Once the console and lower dash panels are out of the way you can get to the nut and screw that hold the left side of the hood over the gauges, and to the two nuts that hold in the gauge cluster. You also need to disconnect the speedometer cable. My speedometer cable had a crew on collar that took a few turns to get off. I have been told that some only need a 1/4 turn to be free.

If you pull and lift on the bottom left corner of the hood over the gauges you can get the stud to slide through the sheet metal, then the wood and then you can lift the left side of the hood just a little. Be careful! Once the left side of the hood was lifted I could pull the gauge cluster out enough to get a ratchet behind the dash to loosen nuts that hold in the gauges. As you are facing the front of the car you rotate the gauges just a little counter-clockwise and they will be free of the gauge cluster. I lifted the gauge cluster up and out of the way.

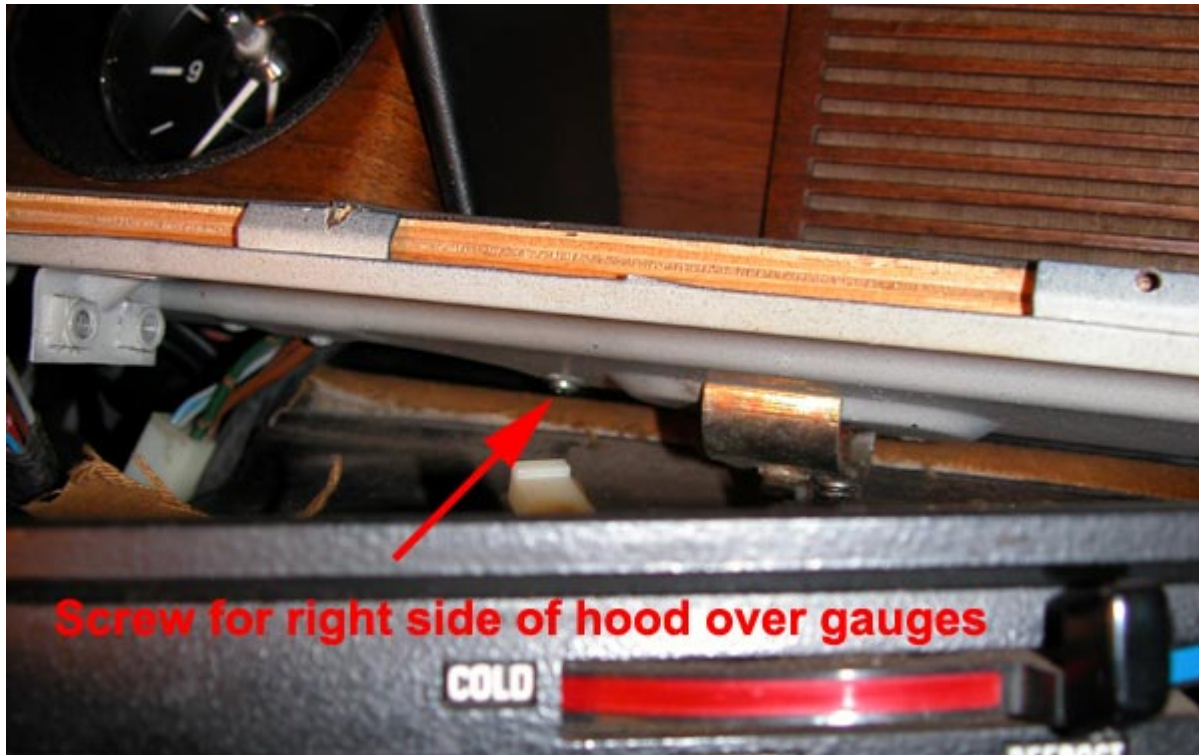
If you need a little more wiggle room in the hood that goes over the gauges then you can take out the screw at the right bottom of the gauge hood. See the picture below. There is also a nut on a stud at the back right of the gauge hood. I think that I could get to it through the speaker hole. I didn't need to take it off to get the gauge cluster out on mine.

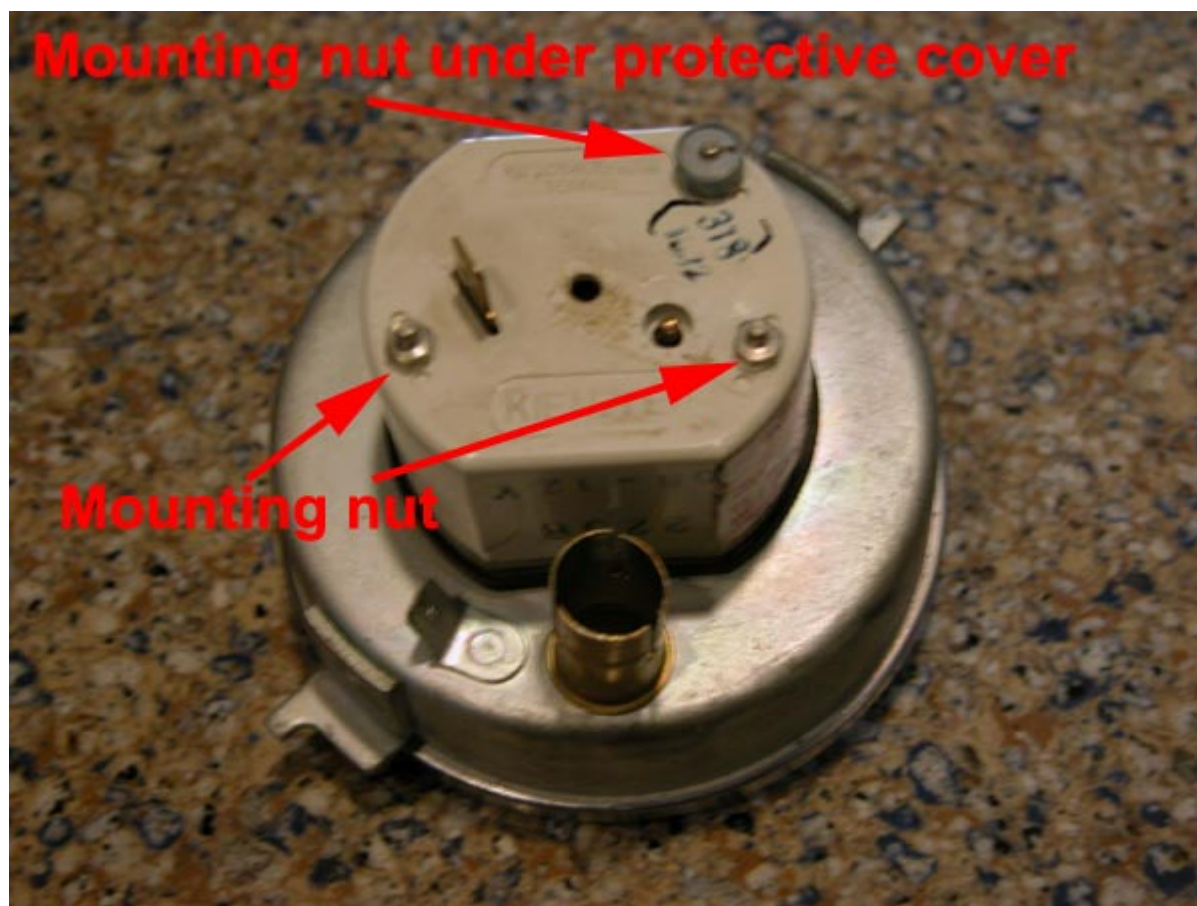
The back of the clock looks like the picture below. You need to remove three nuts to get the plastic cover off. One of the nuts is under a plastic cover. I just turned the grey plastic part around the nut. Two little tabs on the protective cover broke. Since it is way out of warranty I don't care.

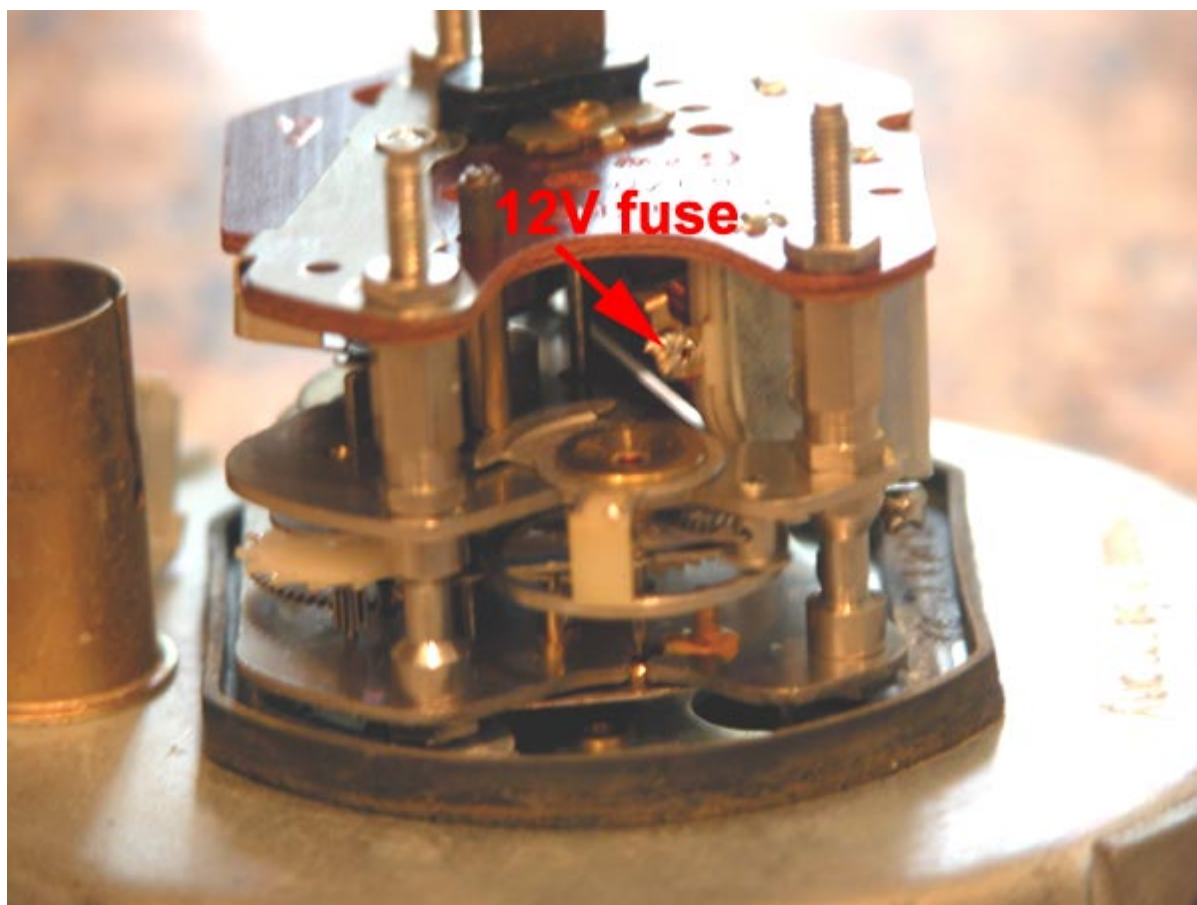
Once you get the plastic cover off it looks like the picture below. There is a metal strip that runs under the circuit board and is supposed to connect the 12V feed tab to the winding coil. The metal strip is connected to the tab on the coil by a small piece of very low temperature solder. Mine was melted and the metal strip had sprung away from the tab. I held the strip in place and used a little dab of solder to hold them together. The clock works great now.
