[Mechanical Tii Distributor '72 ; PN: 0231151008 "JFUD4"](#)

Rebuilding the Bosch 010 Distributor – Part II

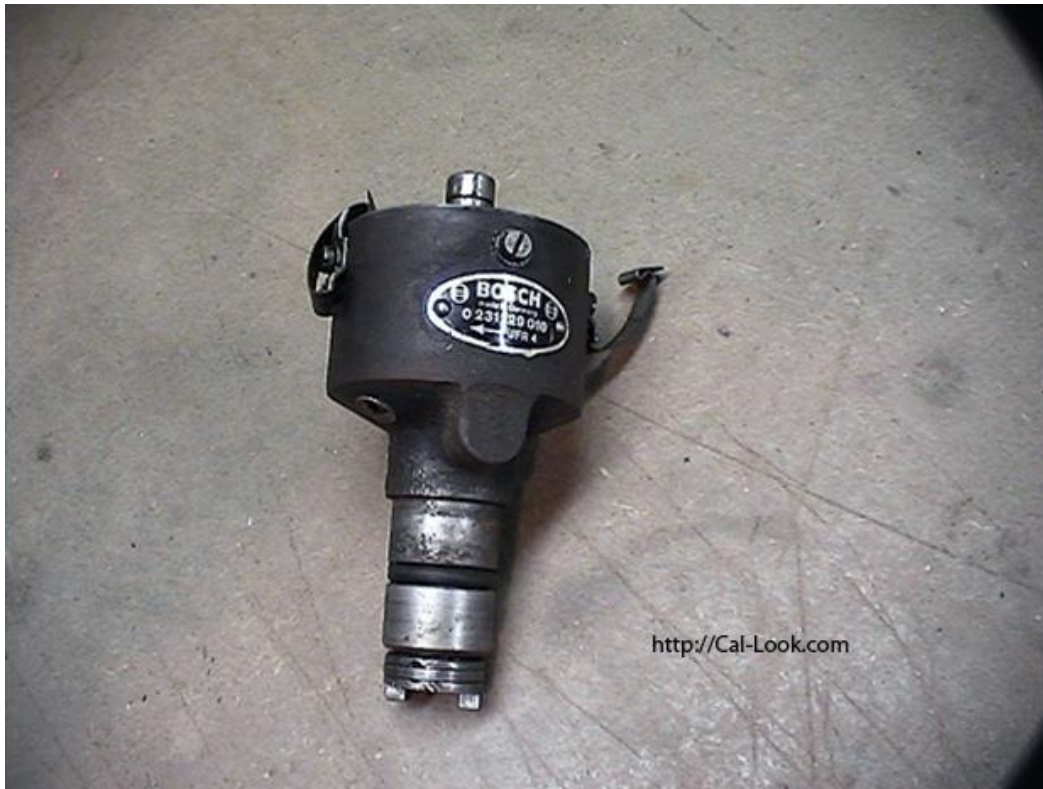
↑ Here's what it looks like when I get

it.

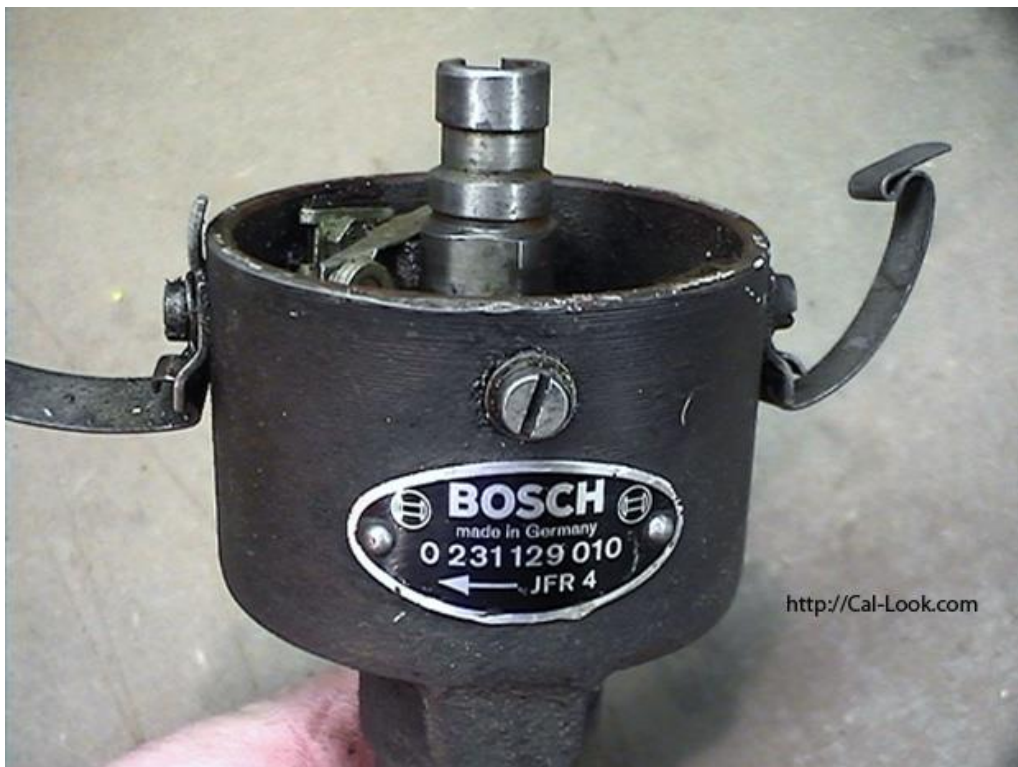
↑ The Bosch badge looks pretty good.

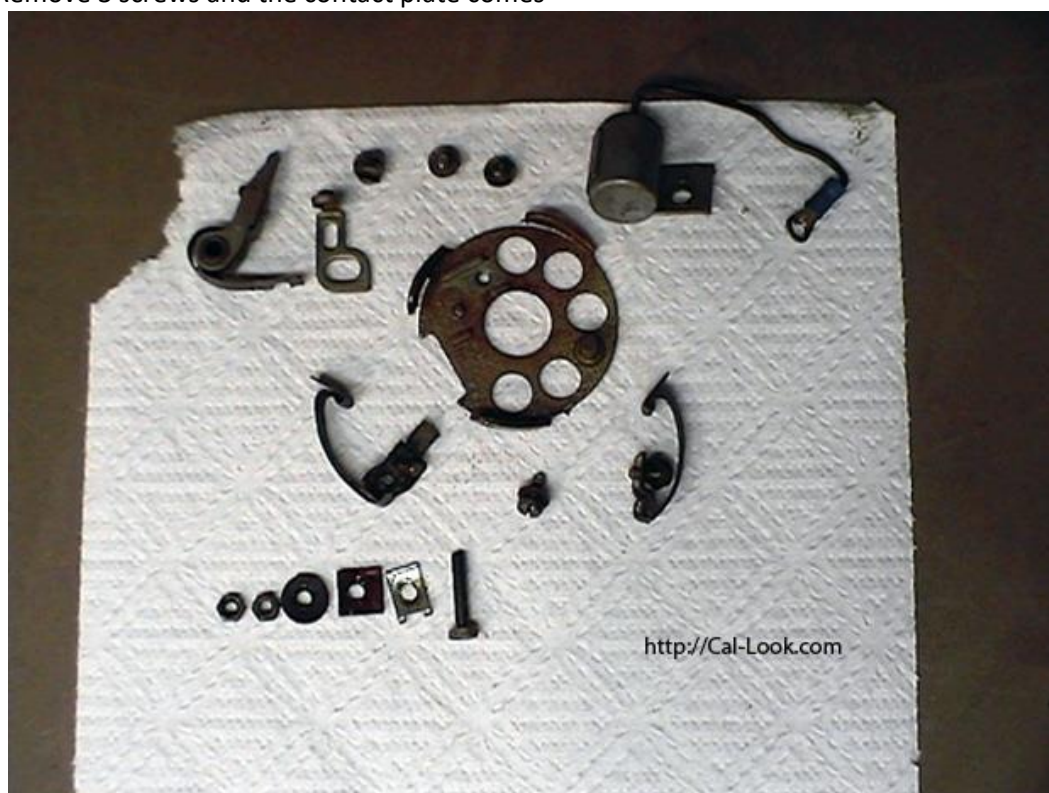
↑ Here's all the parts of the top section.

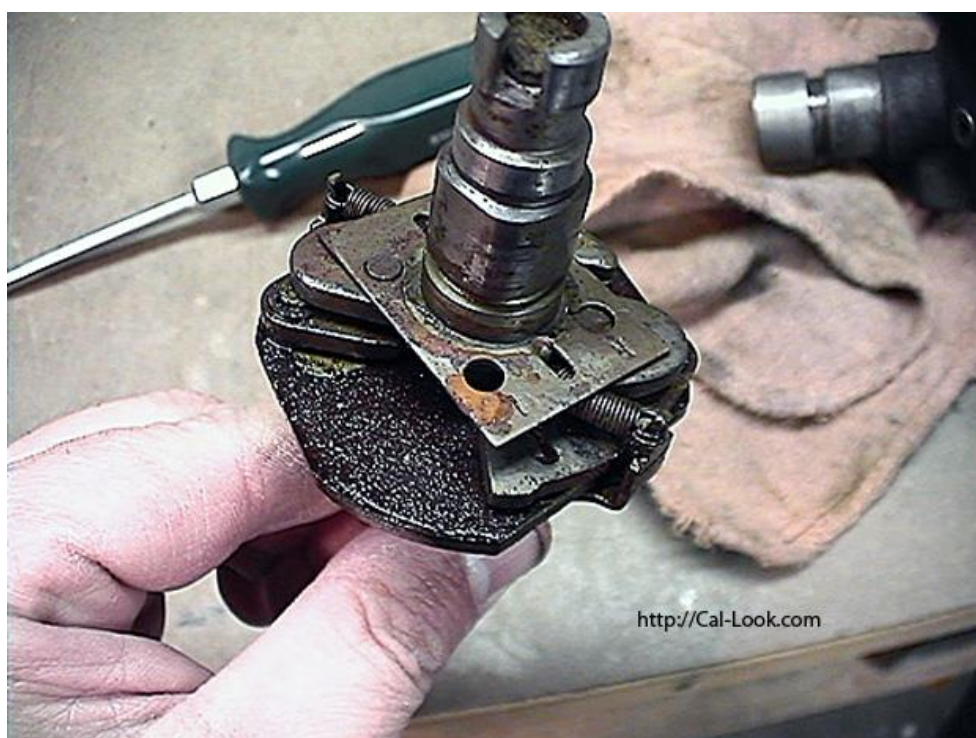
↑ Here's the shaft and advance mechanism. Notice where the 2 springs attach to the plate – you need to remove those and the advance will come apart.

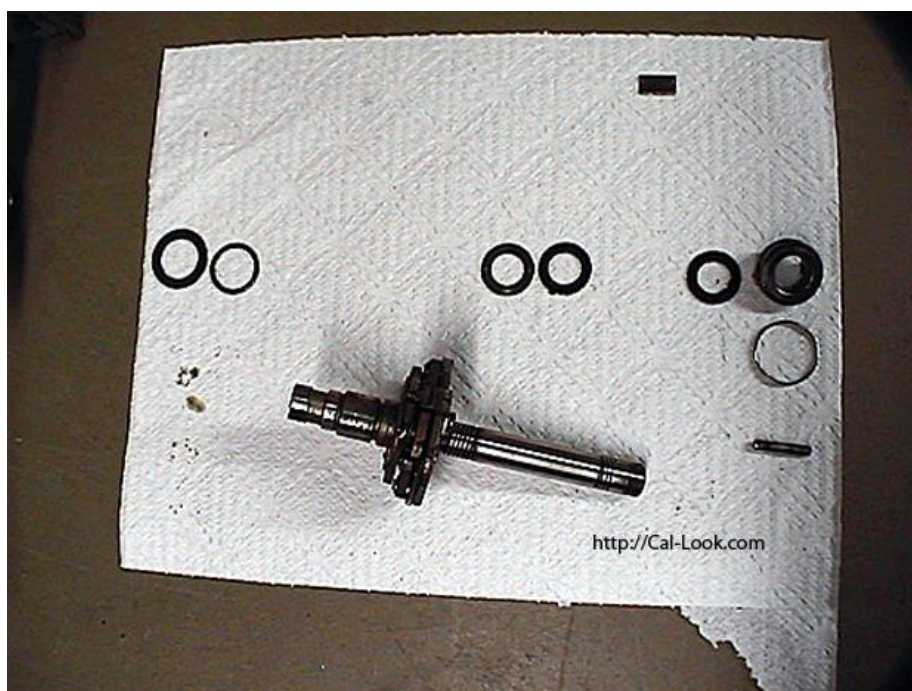
↑ These are the shims and spacers that were removed. The ones on the left sit between the contact place and the advance. The ones in the center sit between the advance and the body. The ones on the right go between the body and the distributor drive.

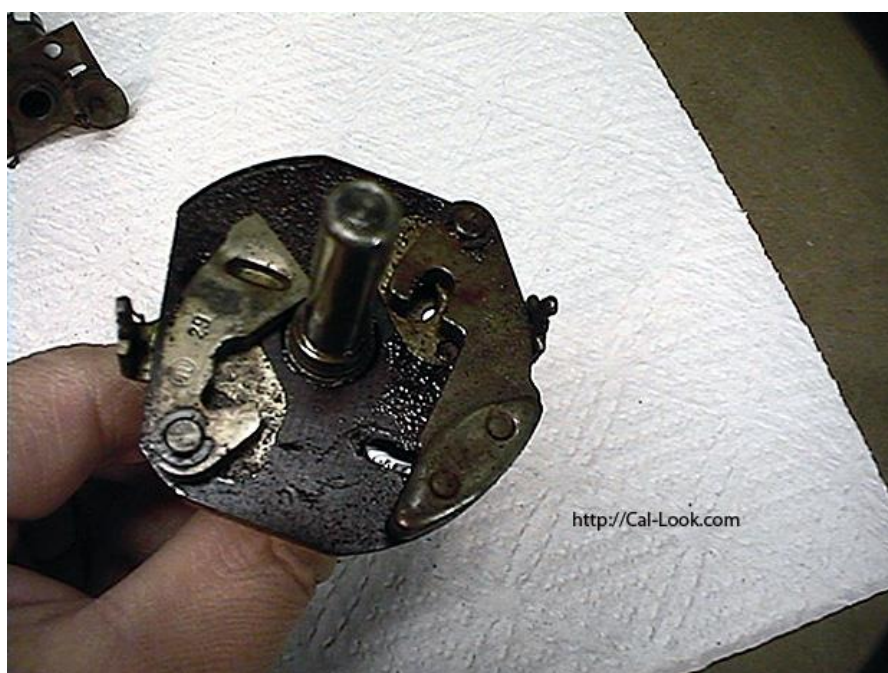
↑ Here's a close up of the advance weights. They are held on with small "C" clips. Also note that there are two different sizes and must go back the same way.
